2. The cause of this accident has been recorded at the NAVAVNSAFECEN indicating PILOT (error in judgment) as the primary factor and WEATHER as an environmental factor.

a. The Accident. At 0455(Q) on 20 July 1967, RF-4B BUNO 153113 assigned to MARINE COMPOSITE RECONNAISSANCE SQUADRON TWO (VMCJ-2) and piloted by CAPT (b) (6), USMC (b) (6), crashed and burned (ALFA) shortly after takeoff from MCAS Cherry Point, North Carolina. Both the pilot and the Reconnaissance Systems Operator (RSO), 2ND LT (b) (6) USMC (b) (6) ejected successfully. The final resting place of the aircraft was located in a swampy, wooded area, four miles from the takeoff end of runway 32. The pilot suffered (b) (6). The RSO suffered (b) (6) but was not wearing gloves during the flight. The accident caused no damage to private property.

M.O.R. CONCLUSIONS concerning RF-4B, Bureau Number 153113 accident on 20 July 1967

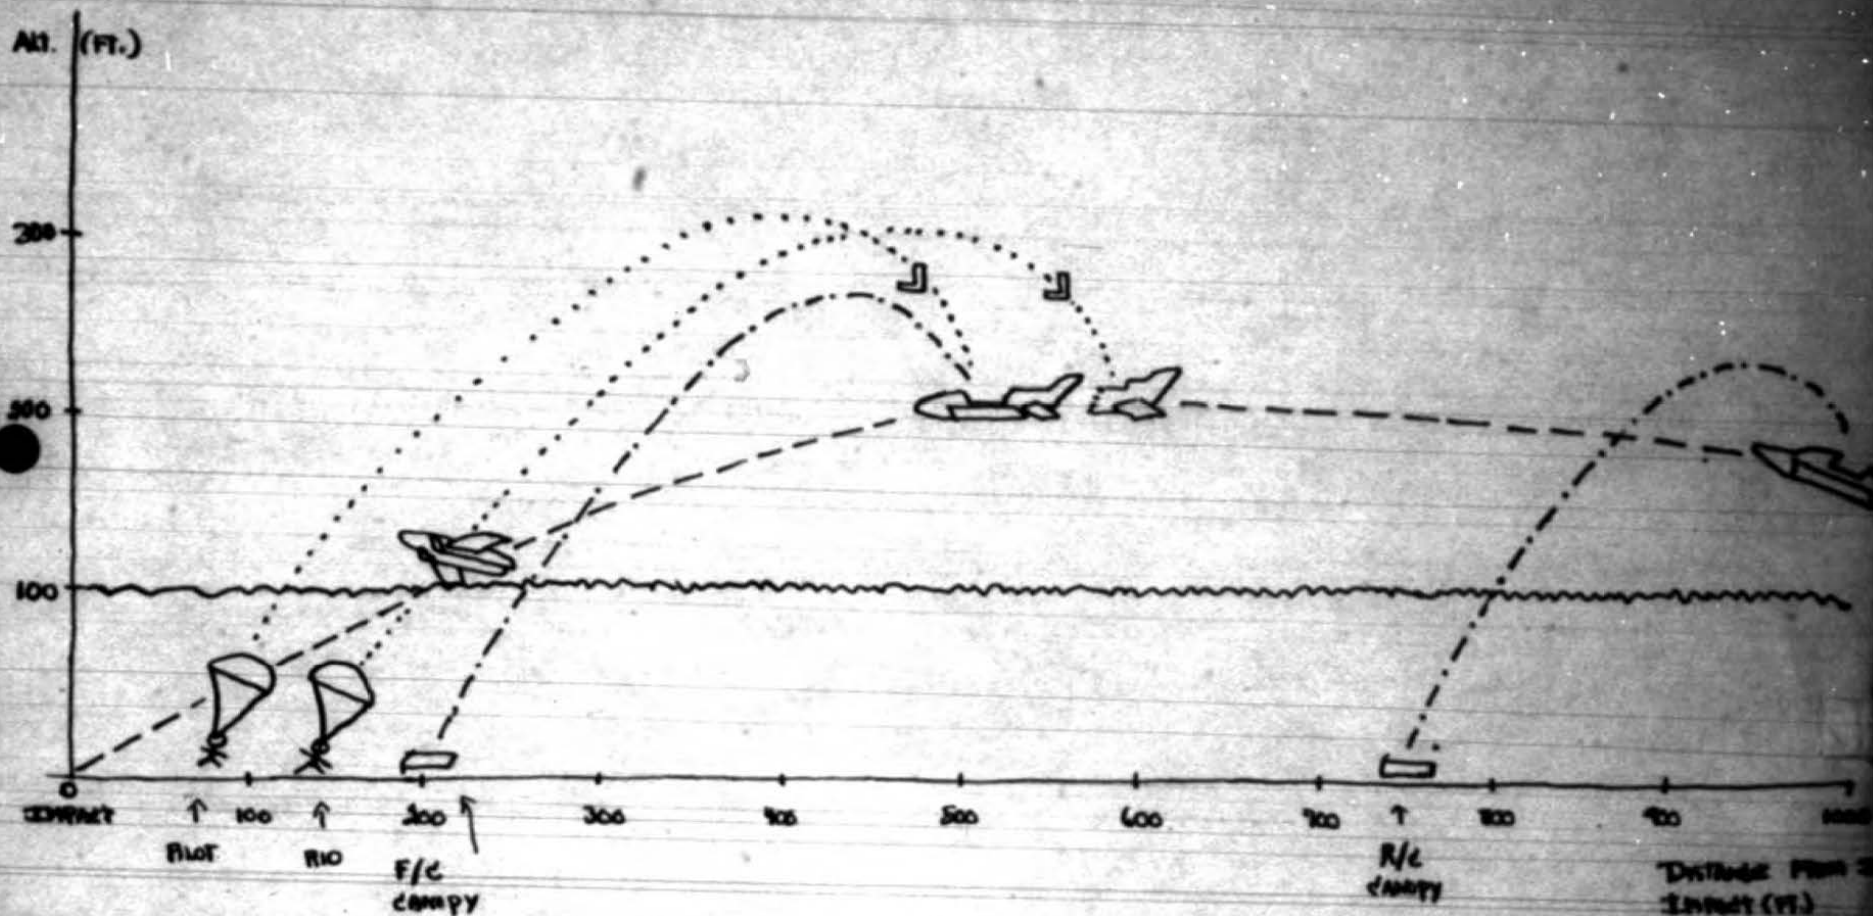
EST. LAUNCH ALTITUDE:
ABOVE TERRAIN - 175'
TERRAIN - 200'

EST. ALTITUDE - 120 KTS

ATTITUDE - LEVEL

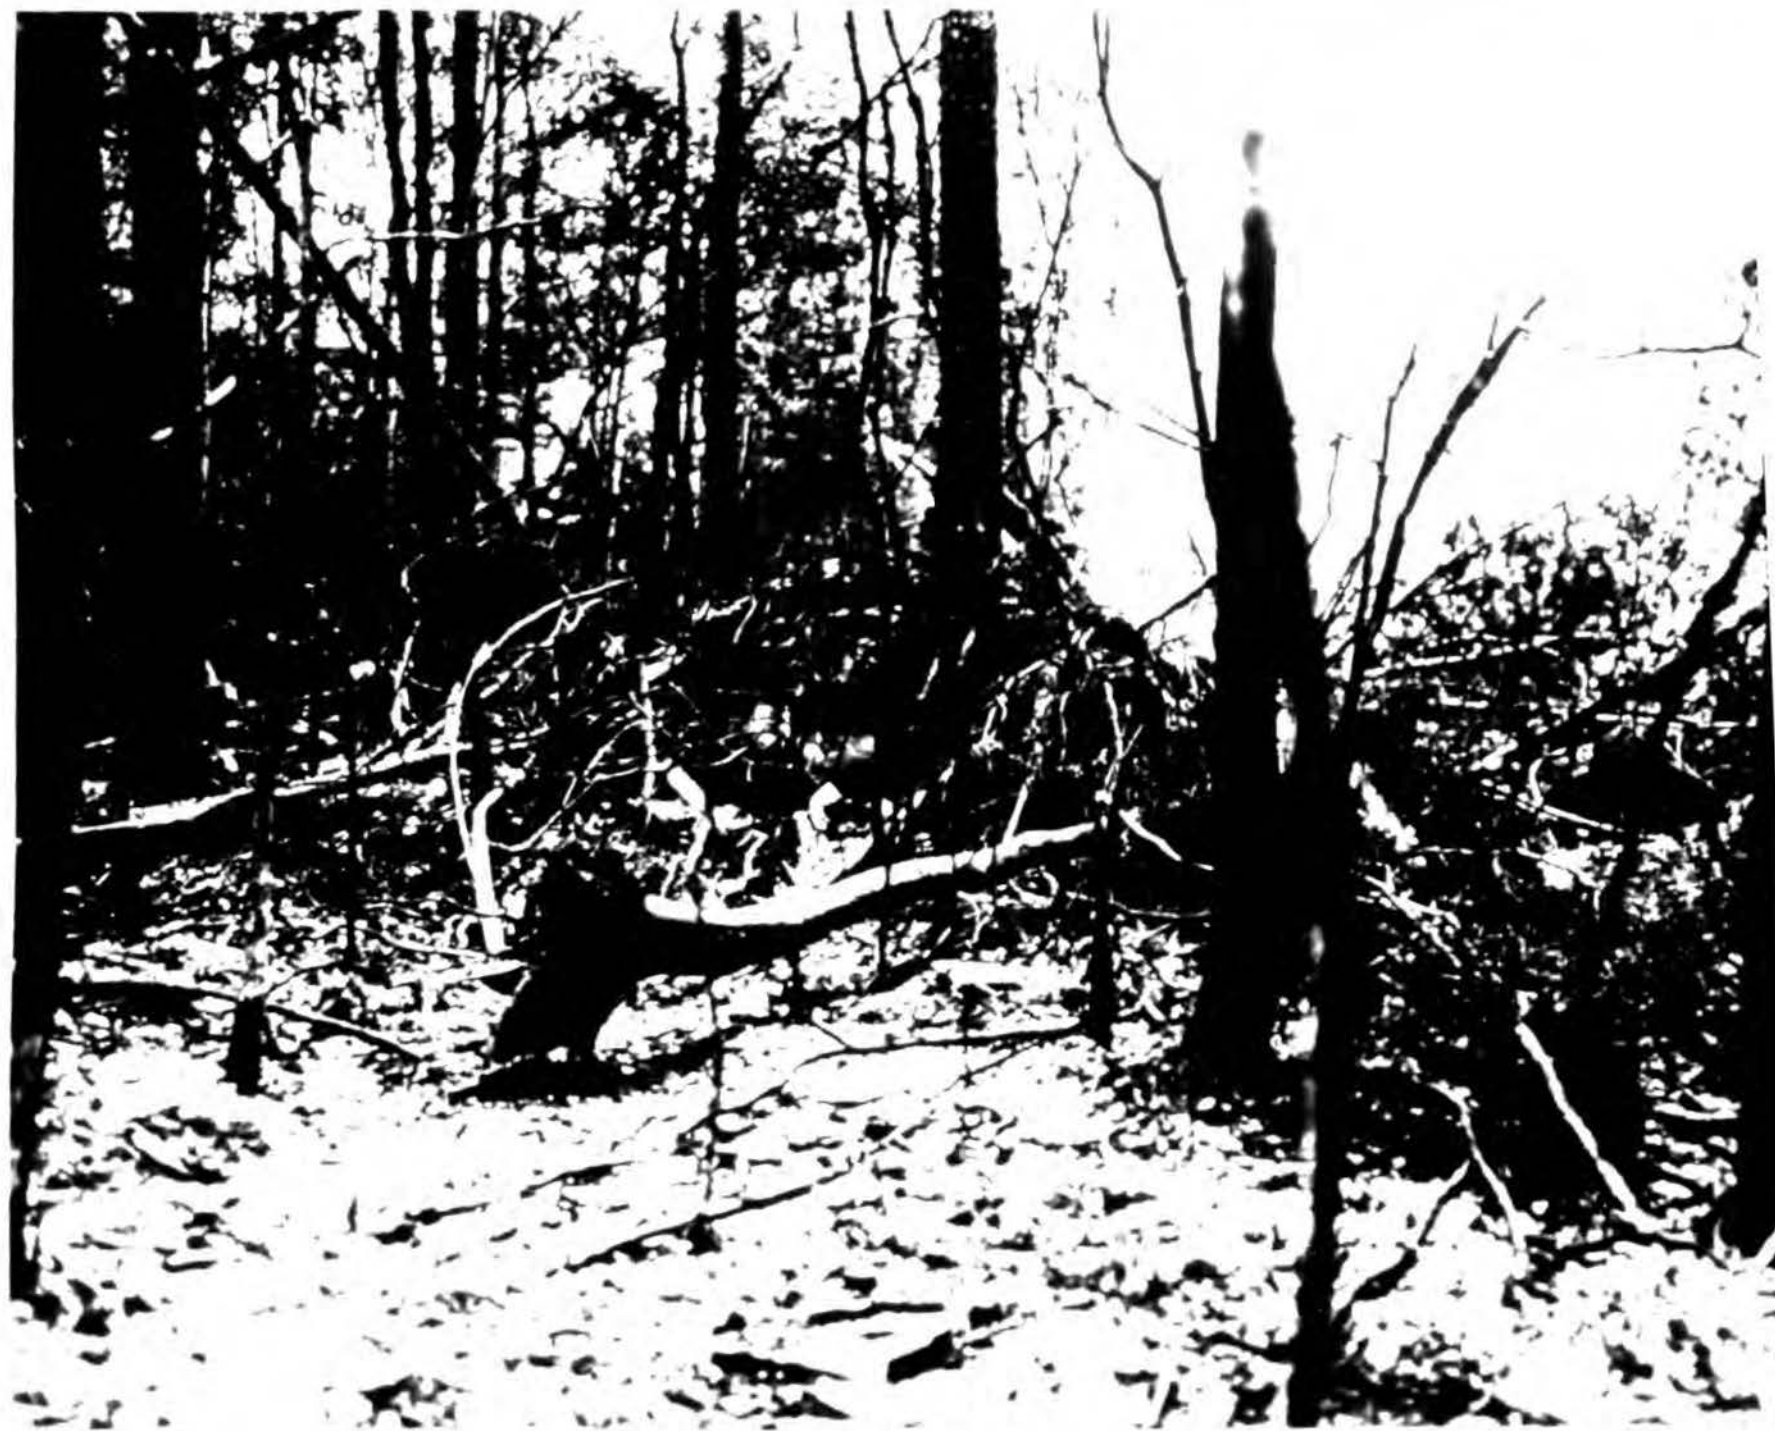
No immediate firefighting. Small pocket fires extinguished with mud and "stomping" eight hours after crash.
